From: Andy Chew <achew@airmonitor.com>
To: "Jerry Finlinson (E-mail)" <Jerry-F@ipsc.com>
Date: 4/15/2004 11:29 AM
Subject: Burner DP transmitter/transducer change out and OFA startup

Subject: RE: ABT/Intermountain Power - Burner IBAMS Airflow Measurement Project - Air Monitor Work Order Number 50633

Jerry Finlinson pointed out to us that there was an as built change to the burner total and static pressure signal take-off fittings depending if the burner was a CW or CCW design. Please see attached PDF of Air Monitor drawing W50633BC REV 1 which addresses this issue.

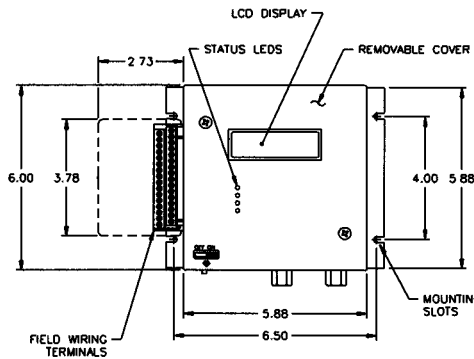
FRONT VIEW

DIMENSIONAL SPECIFICATIONS

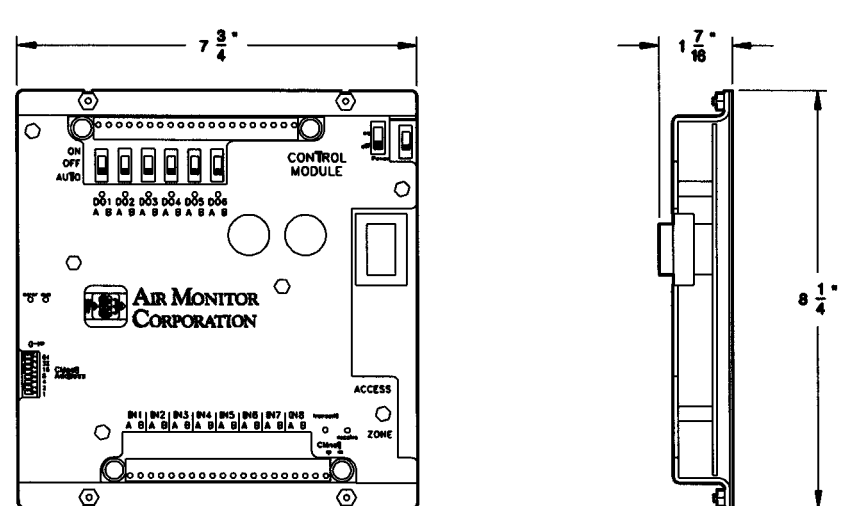
Circuit Protection	Surge protection on input power Optical isolation on RS485 communication line. Arc suppression on relay outputs		
Indication.	LED indicators for status of outputs, power, and communication		
Temperature Limit.	-20°F to 180°F storage -40°F to 150°F operating		
DIMENSIONAL SPECIFICATIONS

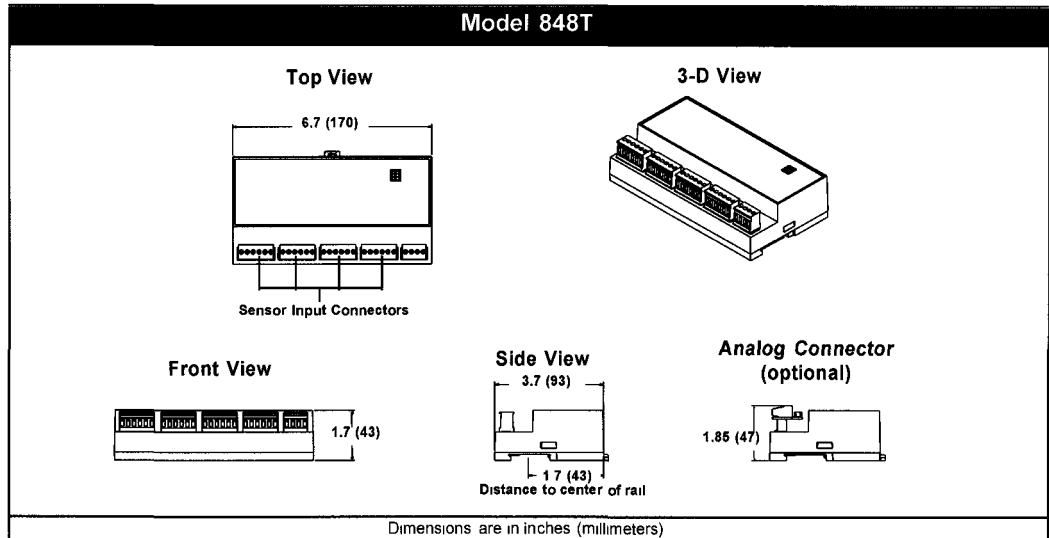
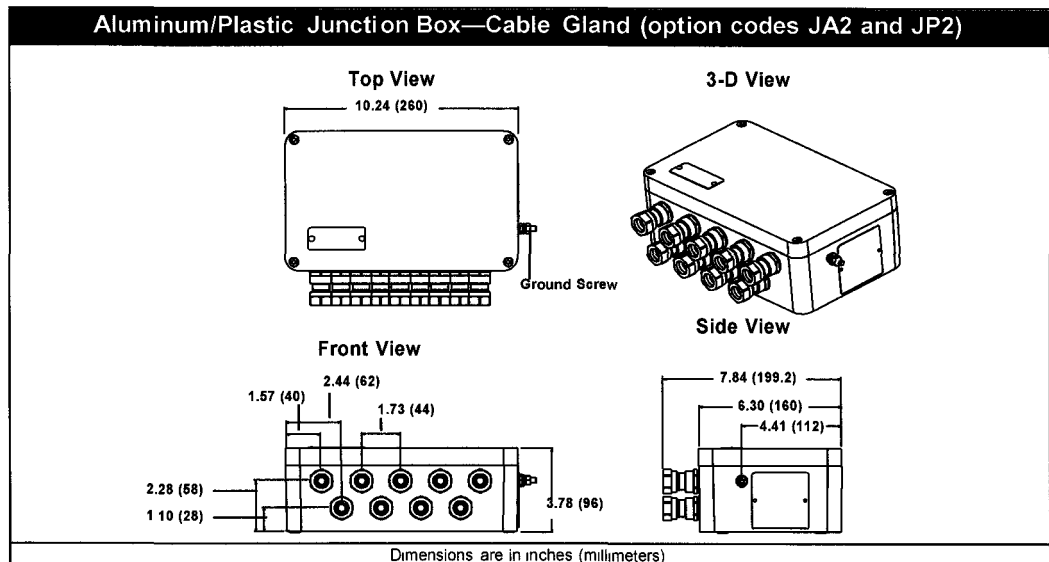
Dimensional Drawings

Junction Boxes with no entries (option codes JP1, JA1, and JS1)— external dimensions are the same as those outlined for the other junction box materials in this section

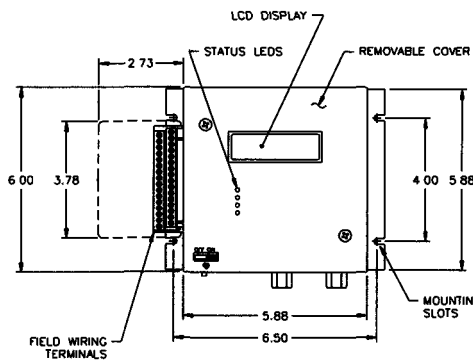
FRONT VIEW

DIMENSIONAL SPECIFICATIONS

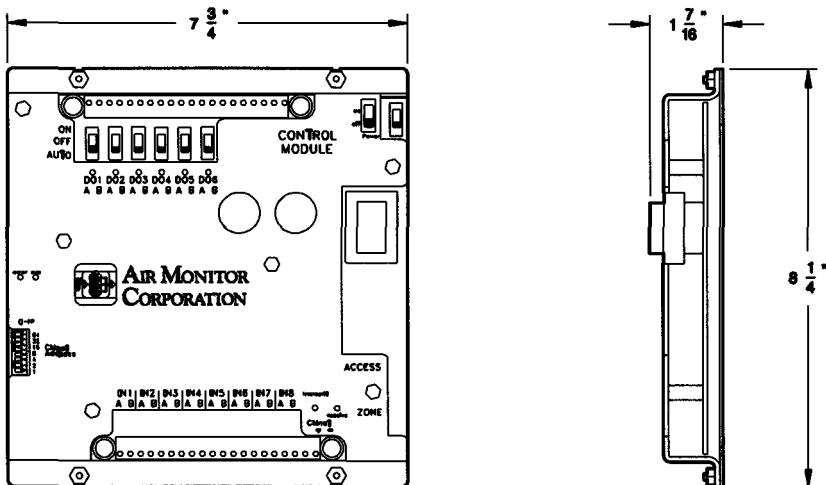
Circuit Protection	Surge protection on input power Optical isolation on RS485 communication line Arc suppression on relay outputs		
Indication.	LED indicators for status of outputs, power, and communication		
Temperature Limit.	-20°F to 180°F storage -40°F to 150°F operating		
DIMENSIONAL SPECIFICATIONS

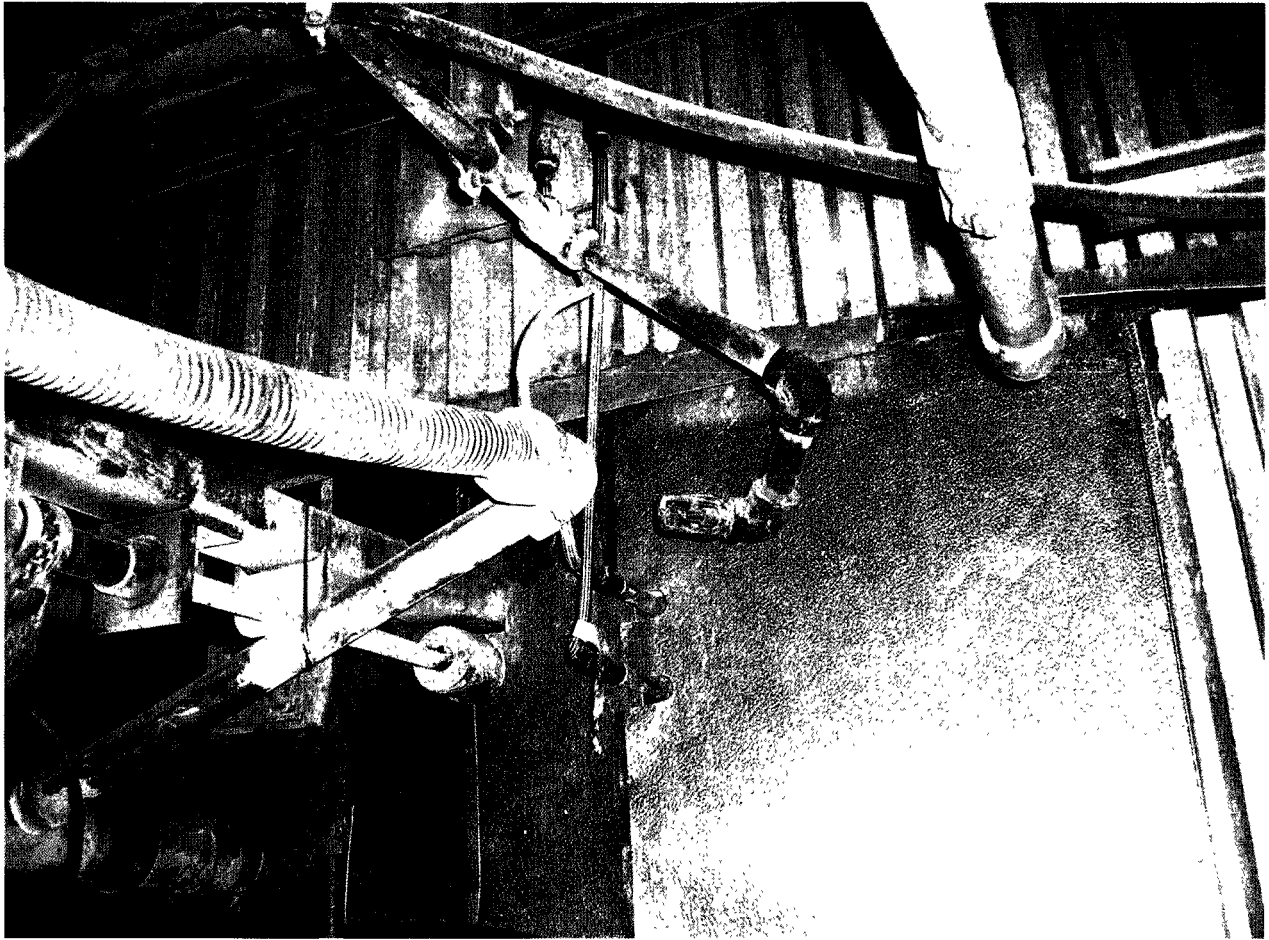
IP7_026496

Please note in the attached photo that the stainless flex line on B4 burner IBAM is too short, it is stretched tight and kinked. Please have someone replace it with a longer one. The current one is about 24 inches. So if there were a 30 or 36, that would be good.

Please note in the attached photo that the stainless flex line on B4 burner IBAM is too short, it is stretched tight and kinked. Please have someone replace it with a longer one. The current one is about 24 inches. So if there were a 30 or 36, that would be good.
